Attachment A: Digital Images

March 10th, 2008

BOE Building 23rd Floor South

Sacramento, CA

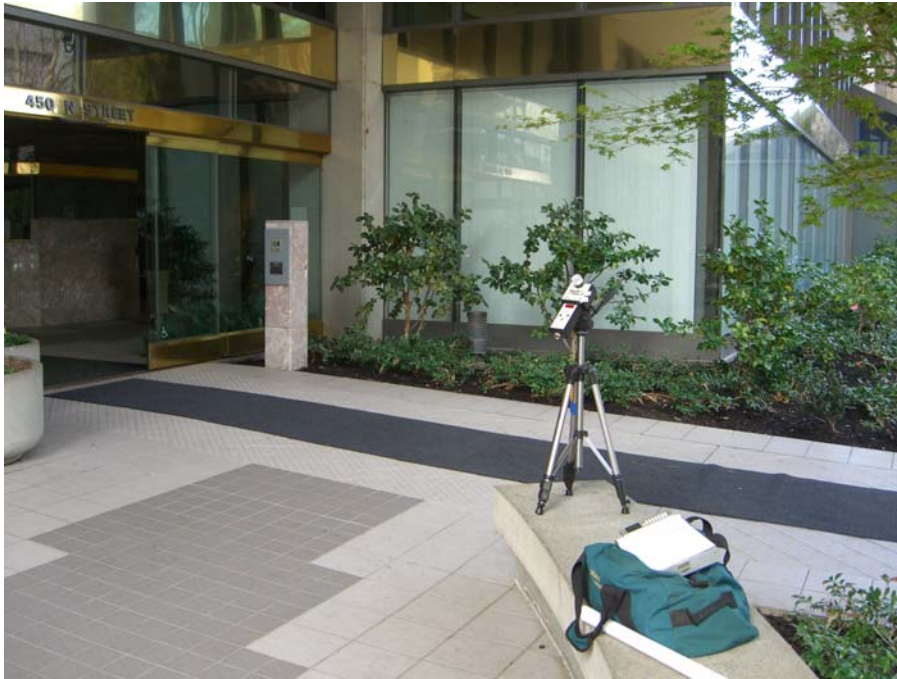
- 1) Image of ambient air sampling location at front entry of BOE Building (Subject Building) located at 450 N Street, Sacramento, California at time of assessment.

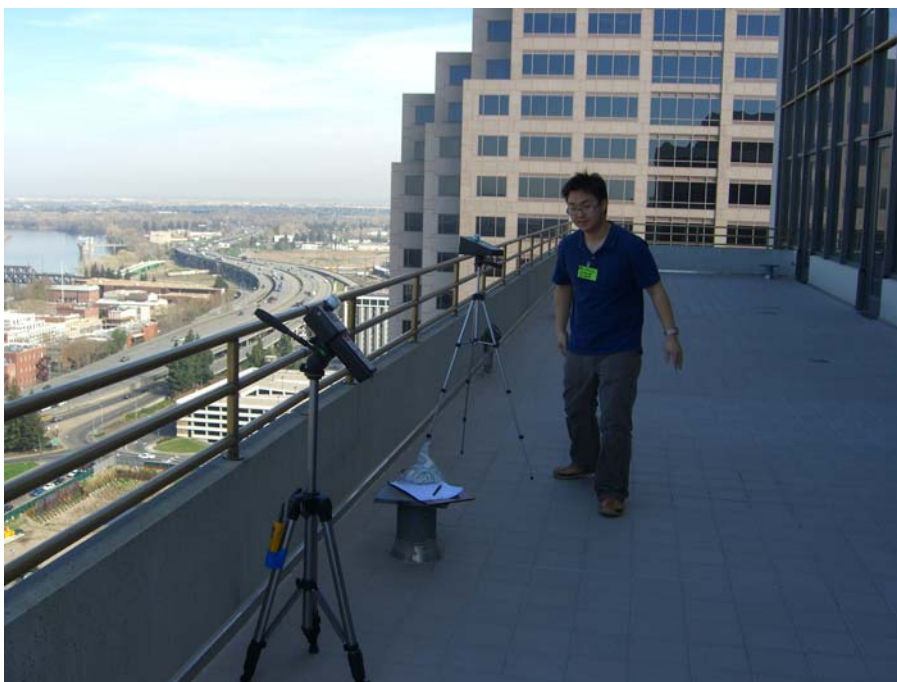
- 2) Image of Ambient air sampling location on balcony of 23 south with HTI technician collecting parallel samples.

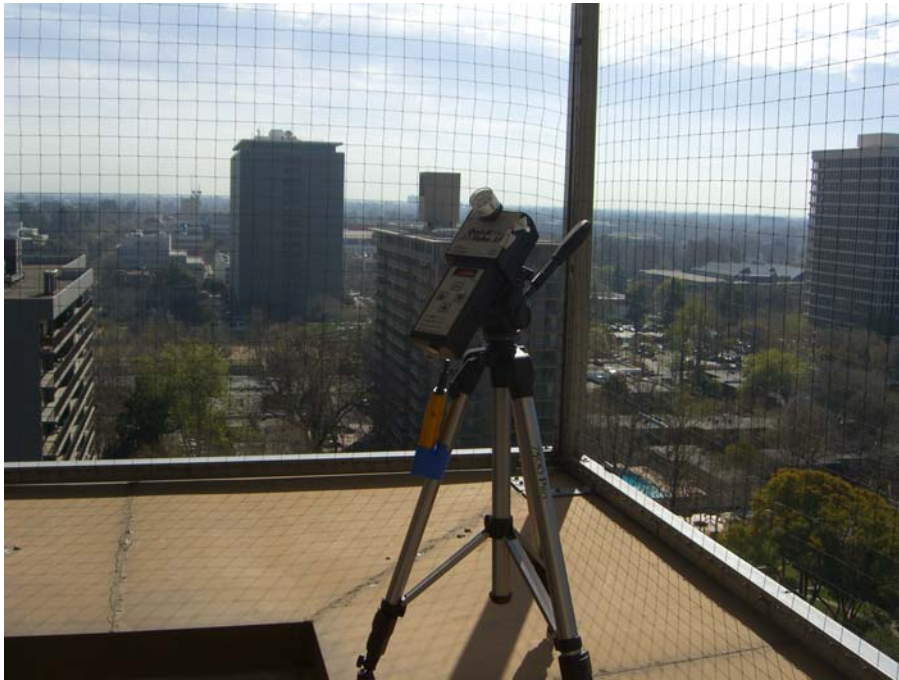
- 3) Image of 12 Floor southeastern balcony during ambient air collection procedures at time of assessment.

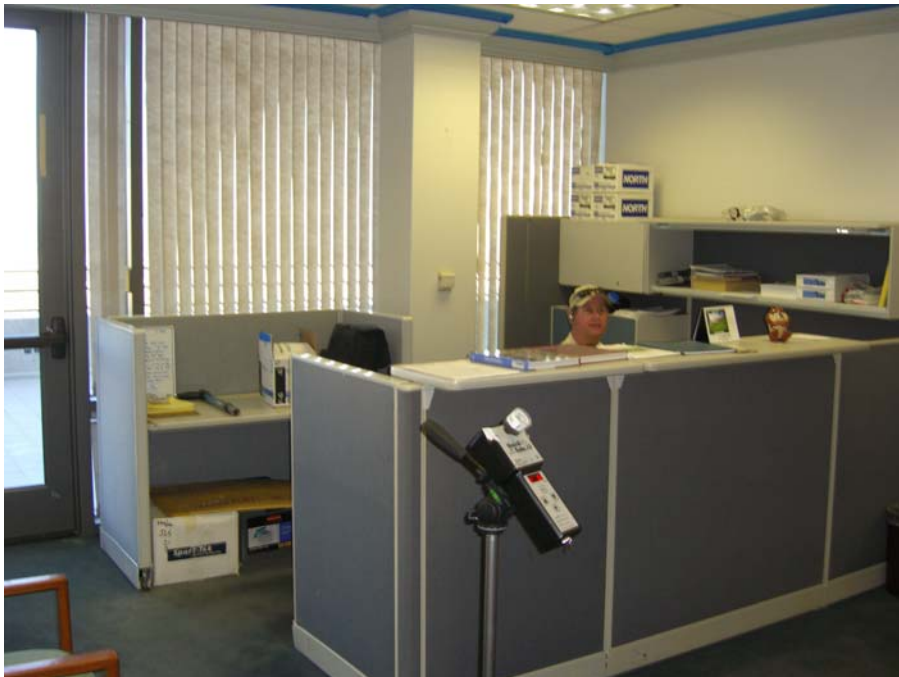
- 4) Image of hallway air sampling within construction offices location (outside containment) adjacent to 23 South containment area at time of assessment.

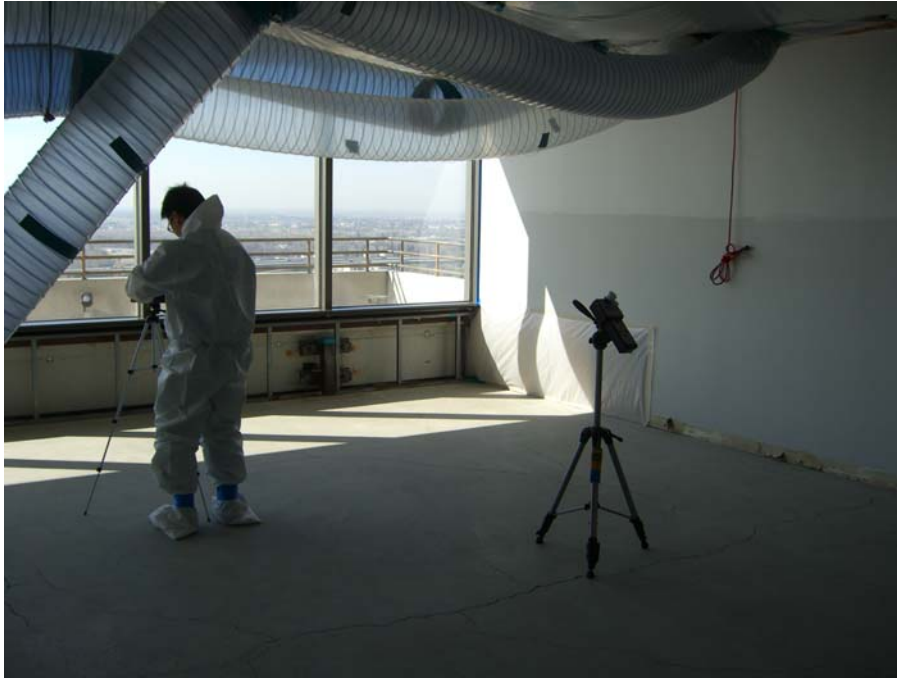
- 5) Image within 23rd Floor south containment area indicating location of air sampling equipment and “parallel” HTI technician activities.

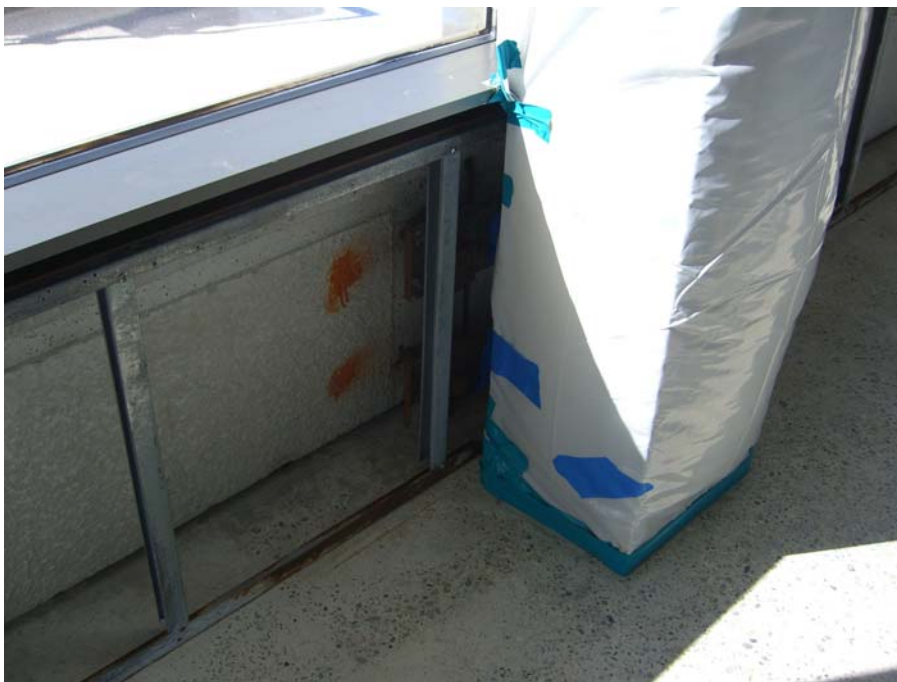
- 6) Image of encased column located at exterior perimeter wall within 23 South containment area following wallboard removal.

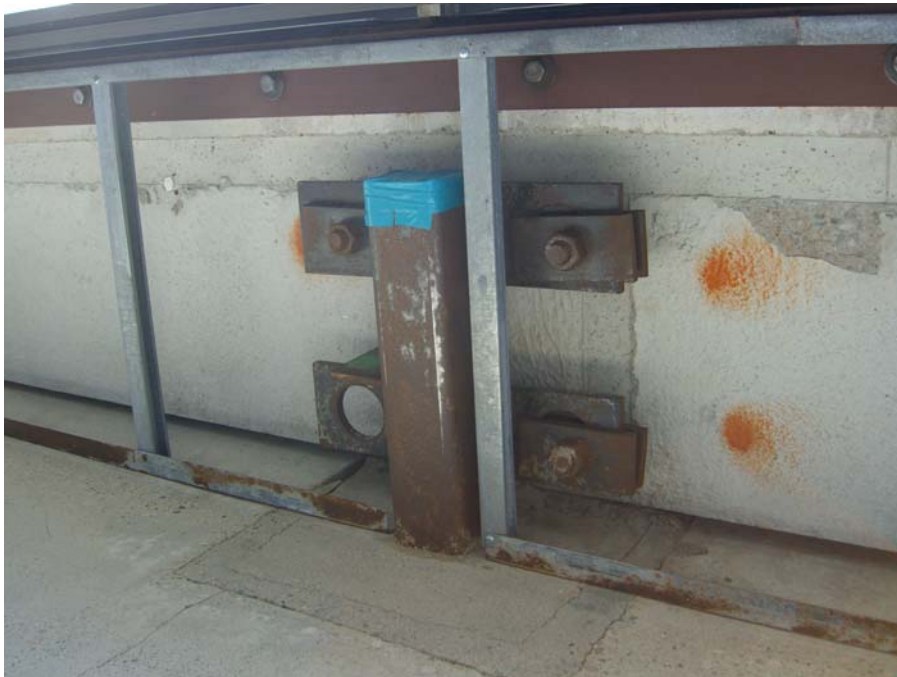
- 7) Close-up image of perimeter wall structures indicating evidence of prior water intrusion (corrosion on floor sill metal) following removal of damaged wallboard materials.

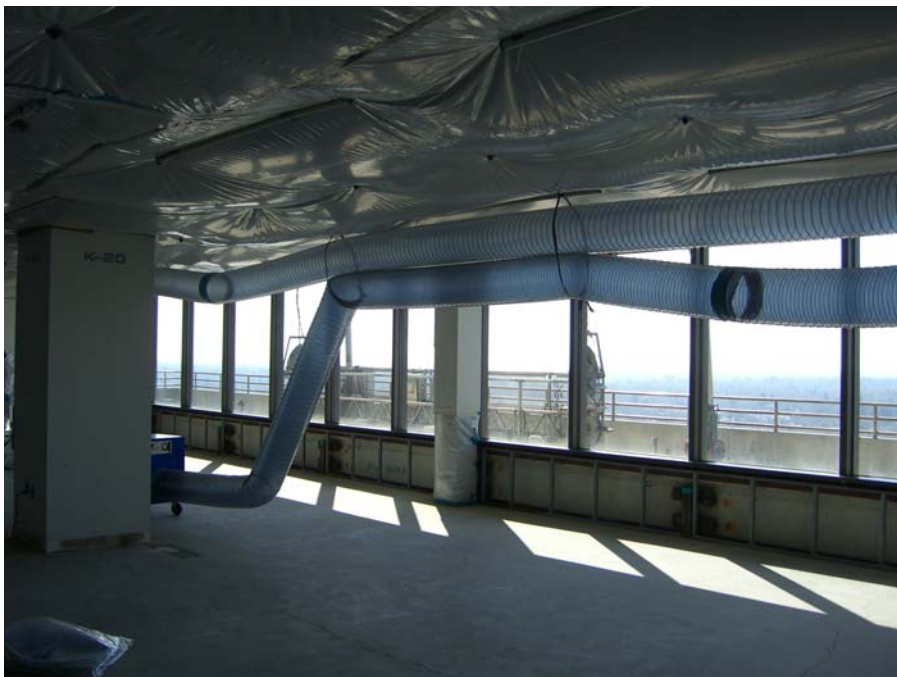
- 8) Wide angle image of 23South containment space indicating ventilation ducting and contained ceiling structures at time of assessment.

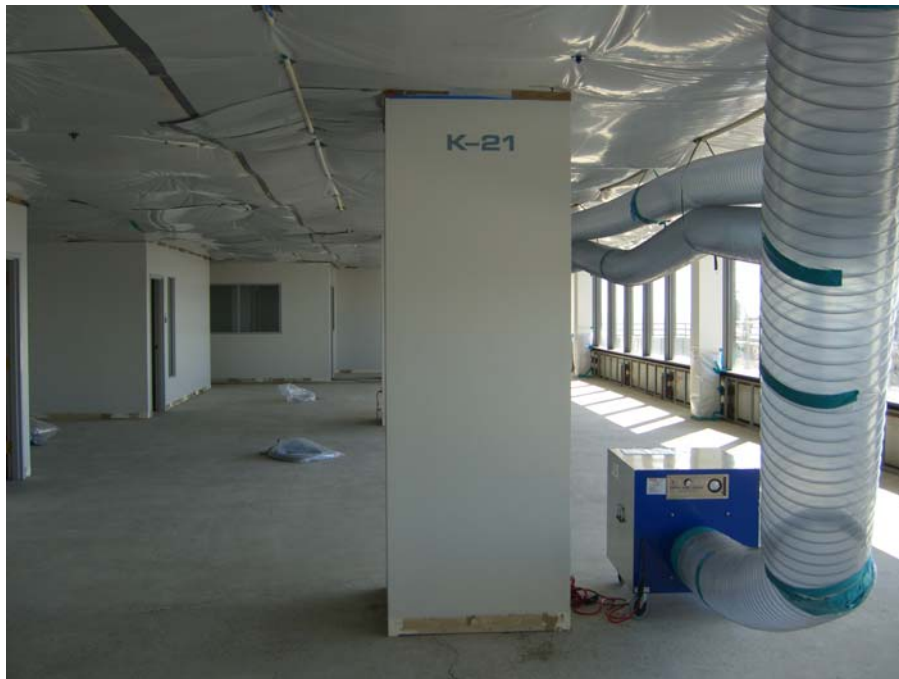
9) Additional image of air handling equipment location within 23 south containment area and exposed concrete subflooring present at time of assessment.

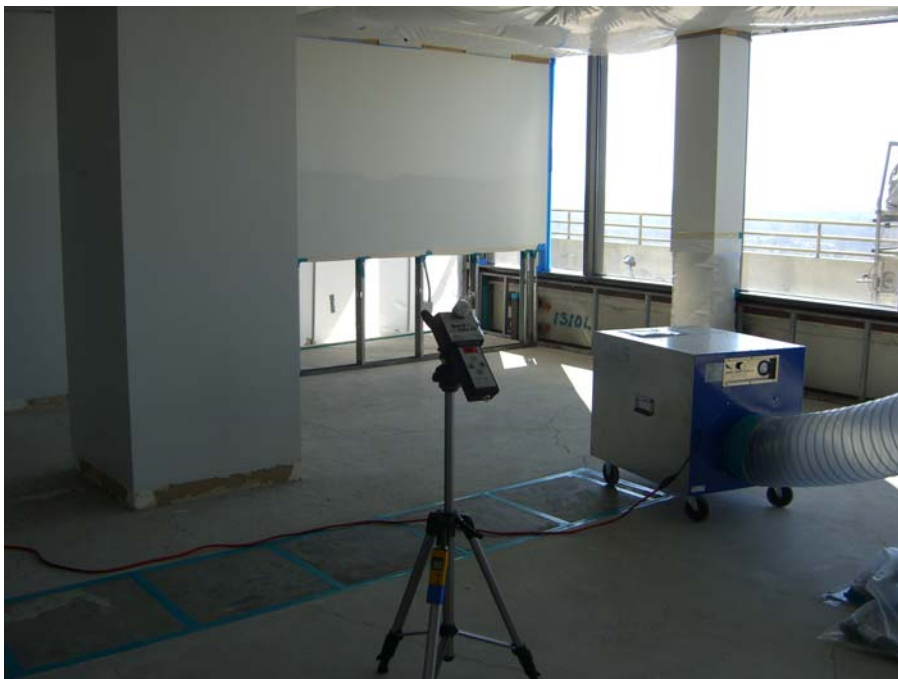
10) Image of air sampling equipment within eastern corner of 23 South containment area.

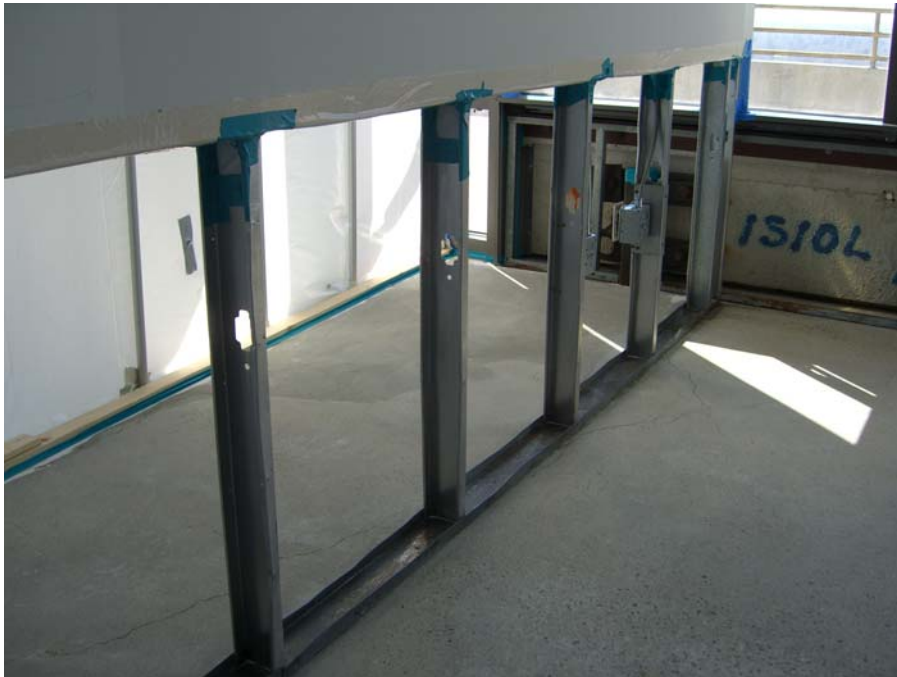
11) Additional image of exposed wall metal framing located at eastern corner of 23 South containment area.

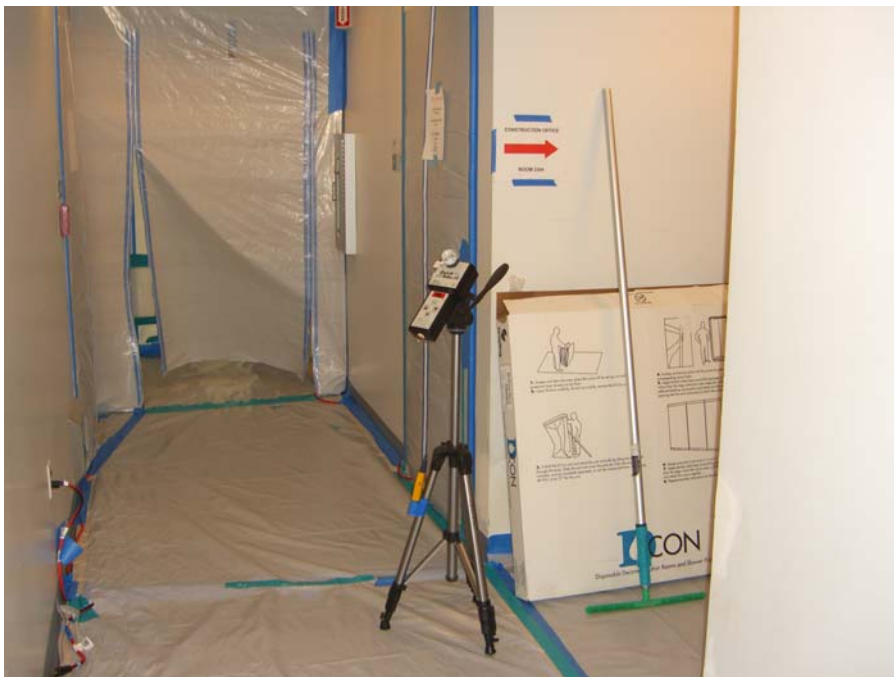
12) Image of air sampling equipment located at exterior hallway of 23 South containment. Sample collected outside containment structures.
